Rapportage Brandproeven t.b.v. “Frozen baguettes”

Oxygen reduction unit

Purpose of the fire tests

Determination of the ignition limit according to the test method as described in VdS 3527:2018 Annex E of the following product:
- A typical method of storing of frozen baguettes in plastic bags, packed in cardboard, wrapped in a layer of plastic, stacked on a wooden pallet.

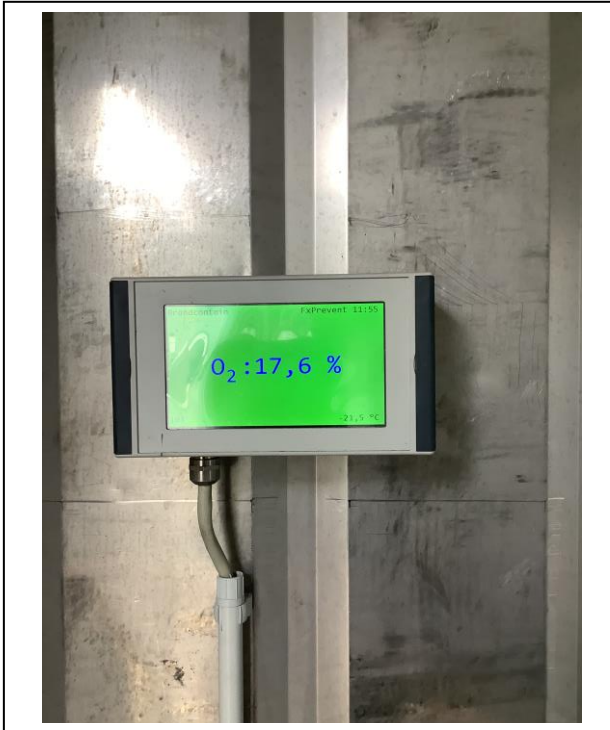
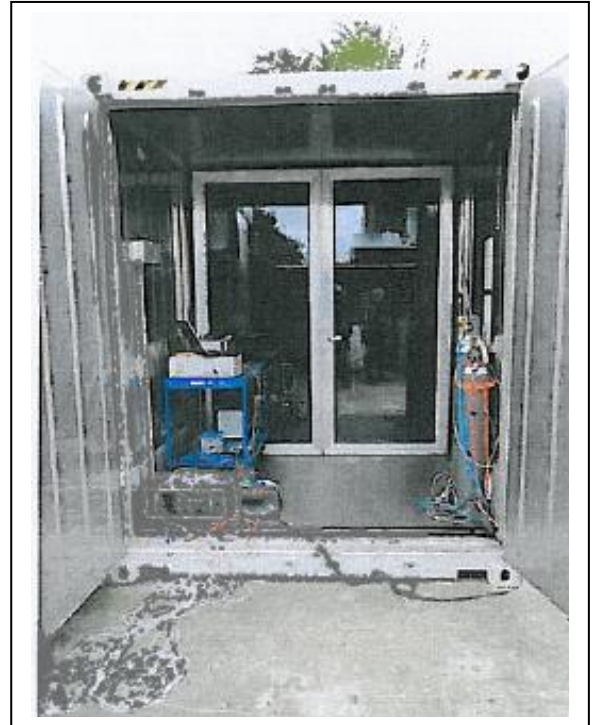
The measurements were performed at the company location of FX Prevent in Honselersdijk. The test setup consisted of a modified sea container, with a transparent partition on 1/3 of the container for observation purposes. The remaining space of the container was furnished with measuring and blowing equipment for the nitrogen supply. The actual nitrogen production was located outside the container against its back wall.

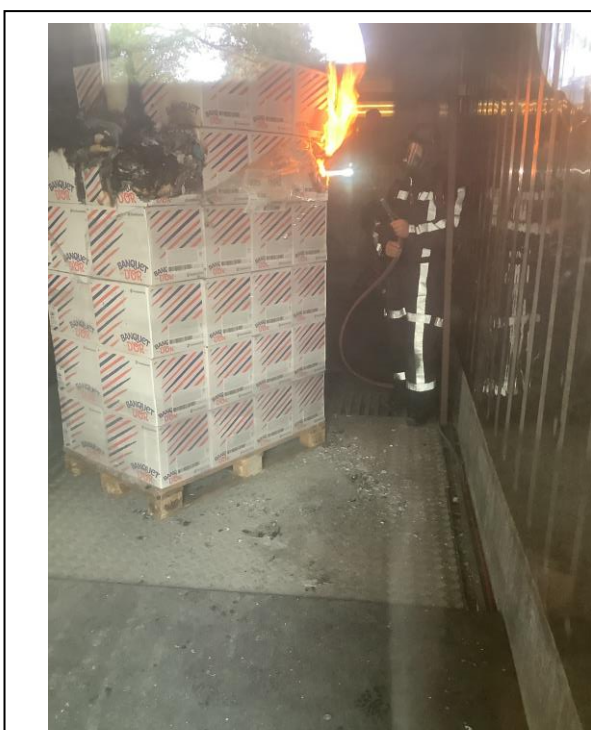
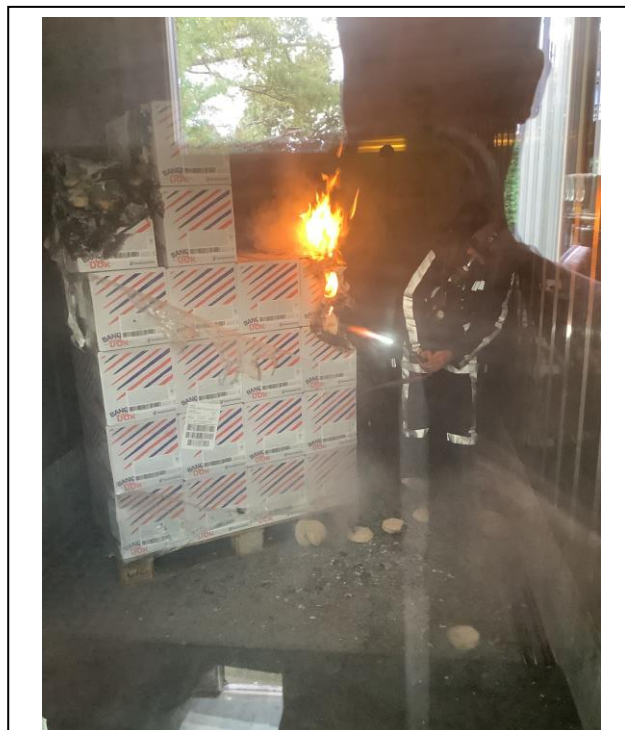
Test stand equipment	Average * oxygen value (%vol)	Average * temperature (in ° Celsius)	Start ignition with gas flame (for a duration of 3 minutes)	After flashing/glowing	Note
7 zakken gestapeld omwikkeld met plastic verpakking					
Test 1	17,4	-22	9:40	8 sec	Instantly extinguished
Test 2	17,8	-23	10:04	Over 1:10 min	Adjacent products catch fire, visible flames on the rest of the product. Test failed
Test 3	17,6	-22	10:52	18 sec	After 18 seconds the flames disappear, little glowing. Test succesfull
Test 4	17,6	-22,5	11:29	51 sec	After 51 seconds the flames disappear, little glowing. Test succesfull
Test 5	17,6	-21,5	11:56	51 sec	After 51 seconds the flames disappear, little glowing. Test succesfull
Note:	<i>After the tests, it was found that at a value of 17,6% was sufficient.</i>
